# 18: SIDE SEWER INSPECTION REPORT

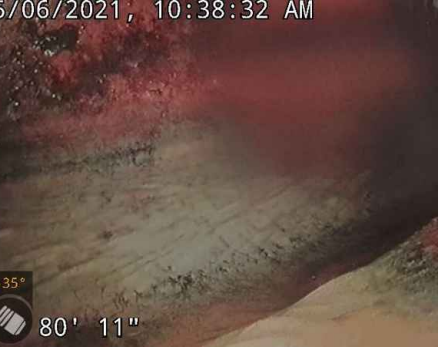
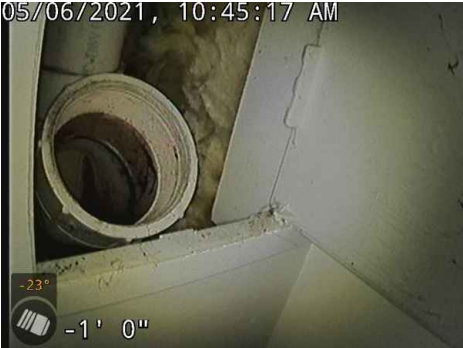
Sewer Lateral Line: Connection to City Sewer Line Observed (Photo)	Sewer Lateral Line: Distance to City Sewer Line Connection (in feet)	Sewer Lateral Line: Lateral Line Access (Cleanout) Location (Photo)
Yes	80	Basement Cleanout

The sewer lateral line was found to be in generally acceptable condition at the time of inspection. Any deficiencies will be noted below.

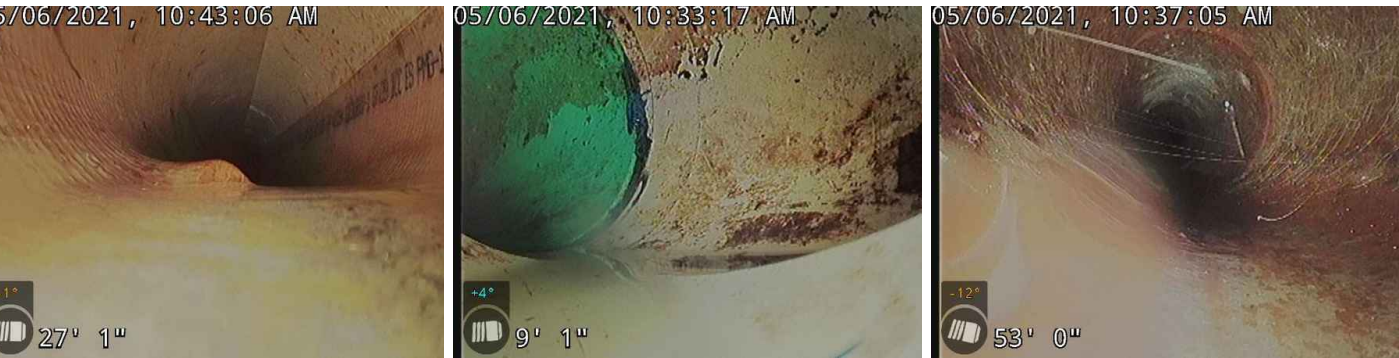
### Sewer Lateral Line: Pipe Material (Photo)

SDR 35, Clay, Liner inside pipe
